Smith Creek Watershed Restoration Plan

Wake and Franklin Counties
North Carolina

Prepared by WK Dickson & Co., Inc.
616 Colonnade Dr.
Charlotte, NC 28205

December 2015

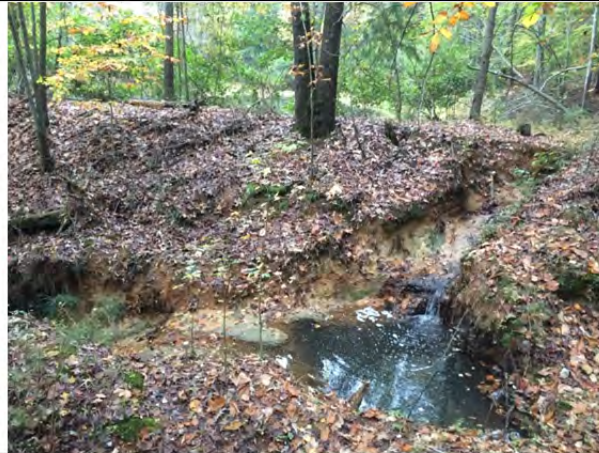
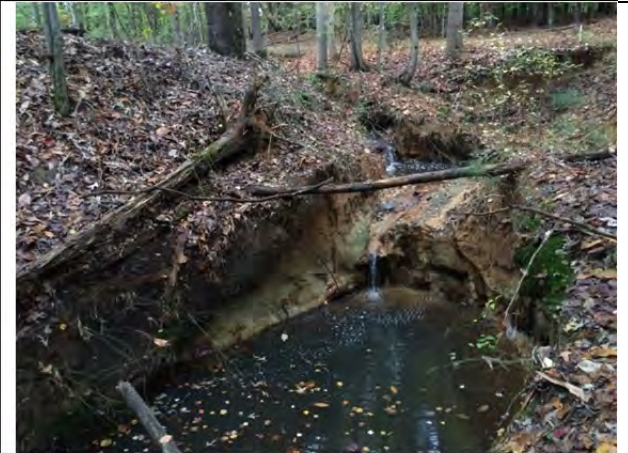
Restoration Priority 4: Dam Failure at Alley Young Park

Watershed Size (ac)	59
Watershed % Urban	92%
Restoration Length (ft)	350
Estimated Cost	\$140,000
Estimated Load Reductions	
Total Nitrogen (lb/yr)	79.23
Total Phosphorous (lb/yr)	30.50
Biological Oxygen Demand (lb/yr)	158.46
Sediment (ton/yr)	43.06

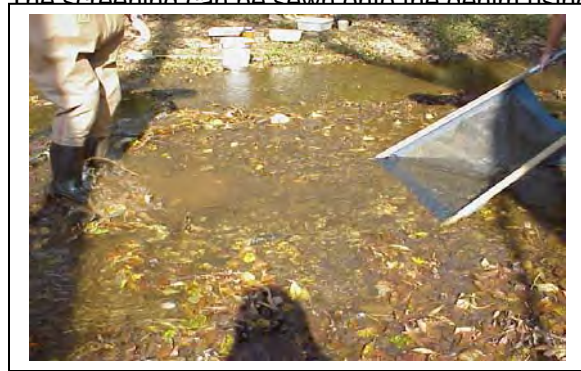
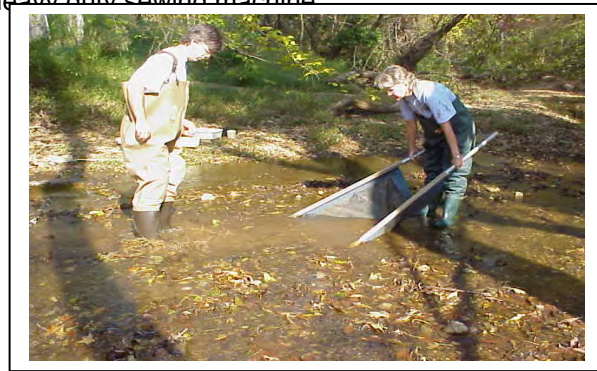
A kick net is an easily constructed and versatile sampling device. It consists of a double layer of flexible nylon door or window screening held in place between two halves of a wooden pole using wood screws. The screening is reinforced with denim along all edges and has lead weights sewn into the bottom edge. The screening can be sewn onto the denim using a heavy duty sewing machine.
